# **REPORT ON IMPROVEMENT OF ALPINE MEADOWS AND ESTABLISHING WATERHOLES IN THE MANITING/JARIBUSA REGION OF THE PARK.**

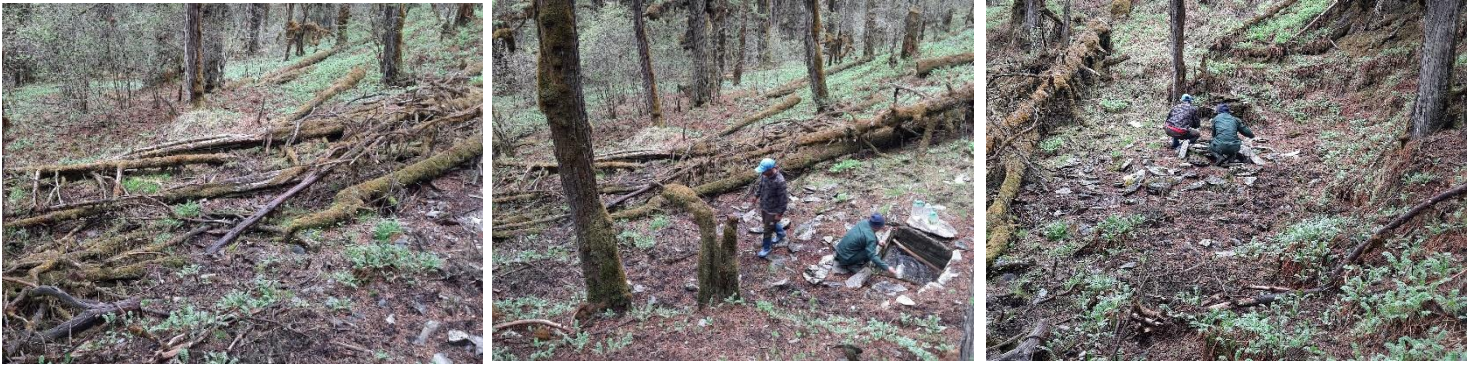
**Photo: Before work execution**

Waterholes were established by fencing the water source with sawn timber, measuring an area of 7.20m x 8.0m. Additionally, two drinking ponds (for yaks, cattle and wild animals) were created just 10 meters below the drinking water source, measuring 2.0m x 2.0m x 0.70m and 3.20m x 2.0m x 0.70m, respectively.

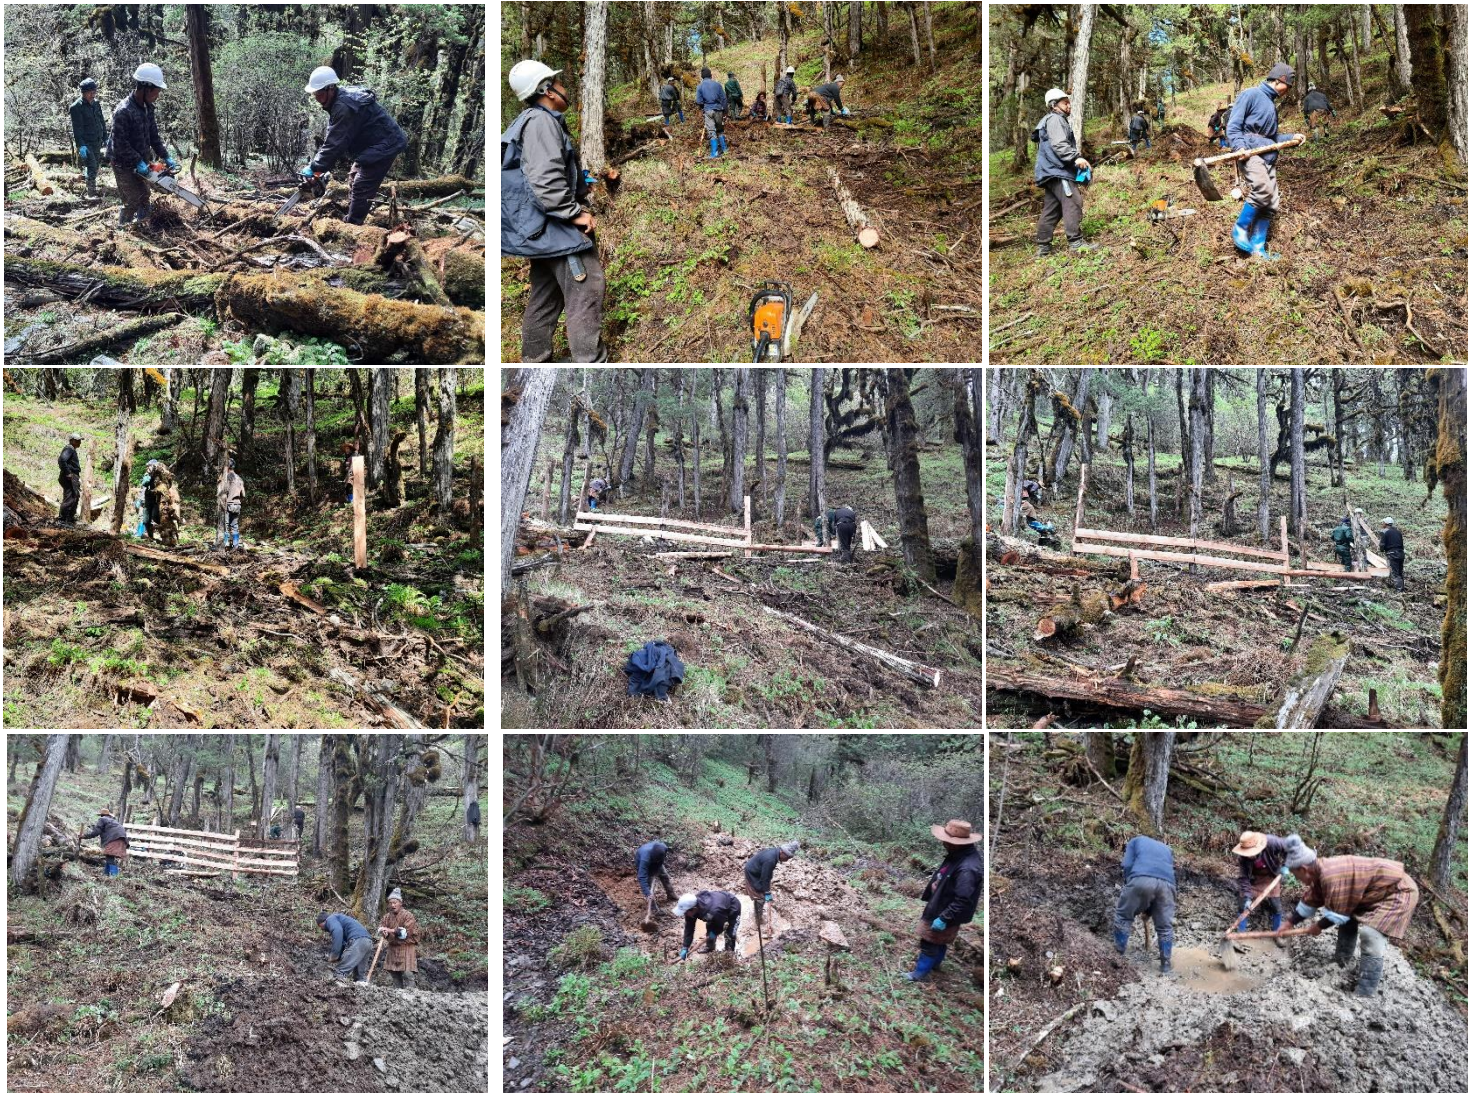
**Photo: Work execution**

To ensure a constant and secure supply of drinking water for herders, yaks, cattle, and wildlife sustainably, efforts were made to protect and conserve waterholes. This involved enclosing the water source with fencing to maintain a continuous provision of safe drinking water for herders, while also establishing waterholes by digging two ponds positioned just 10 meters below the primary drinking water source for yaks, cattle, and wild animals.

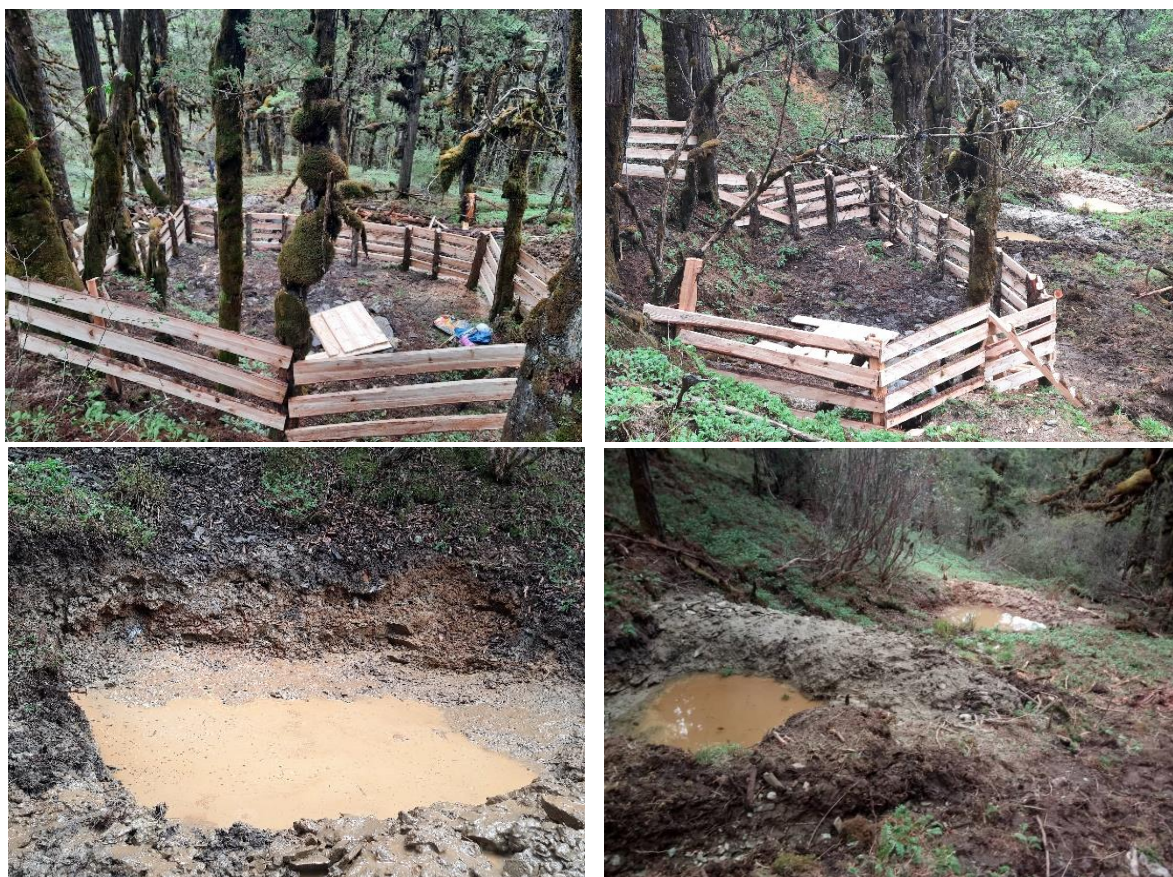
**Photo: After work completion**

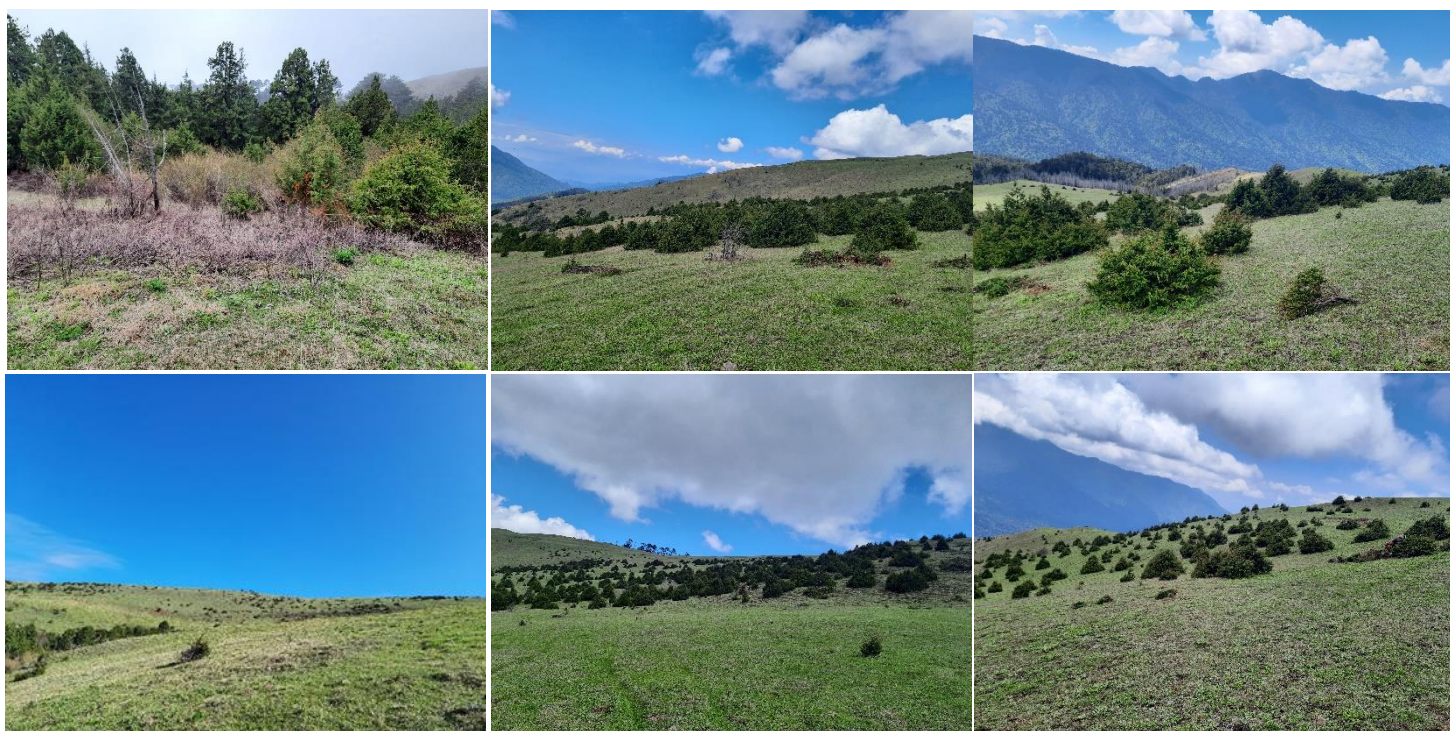
**Photo: Before work execution**

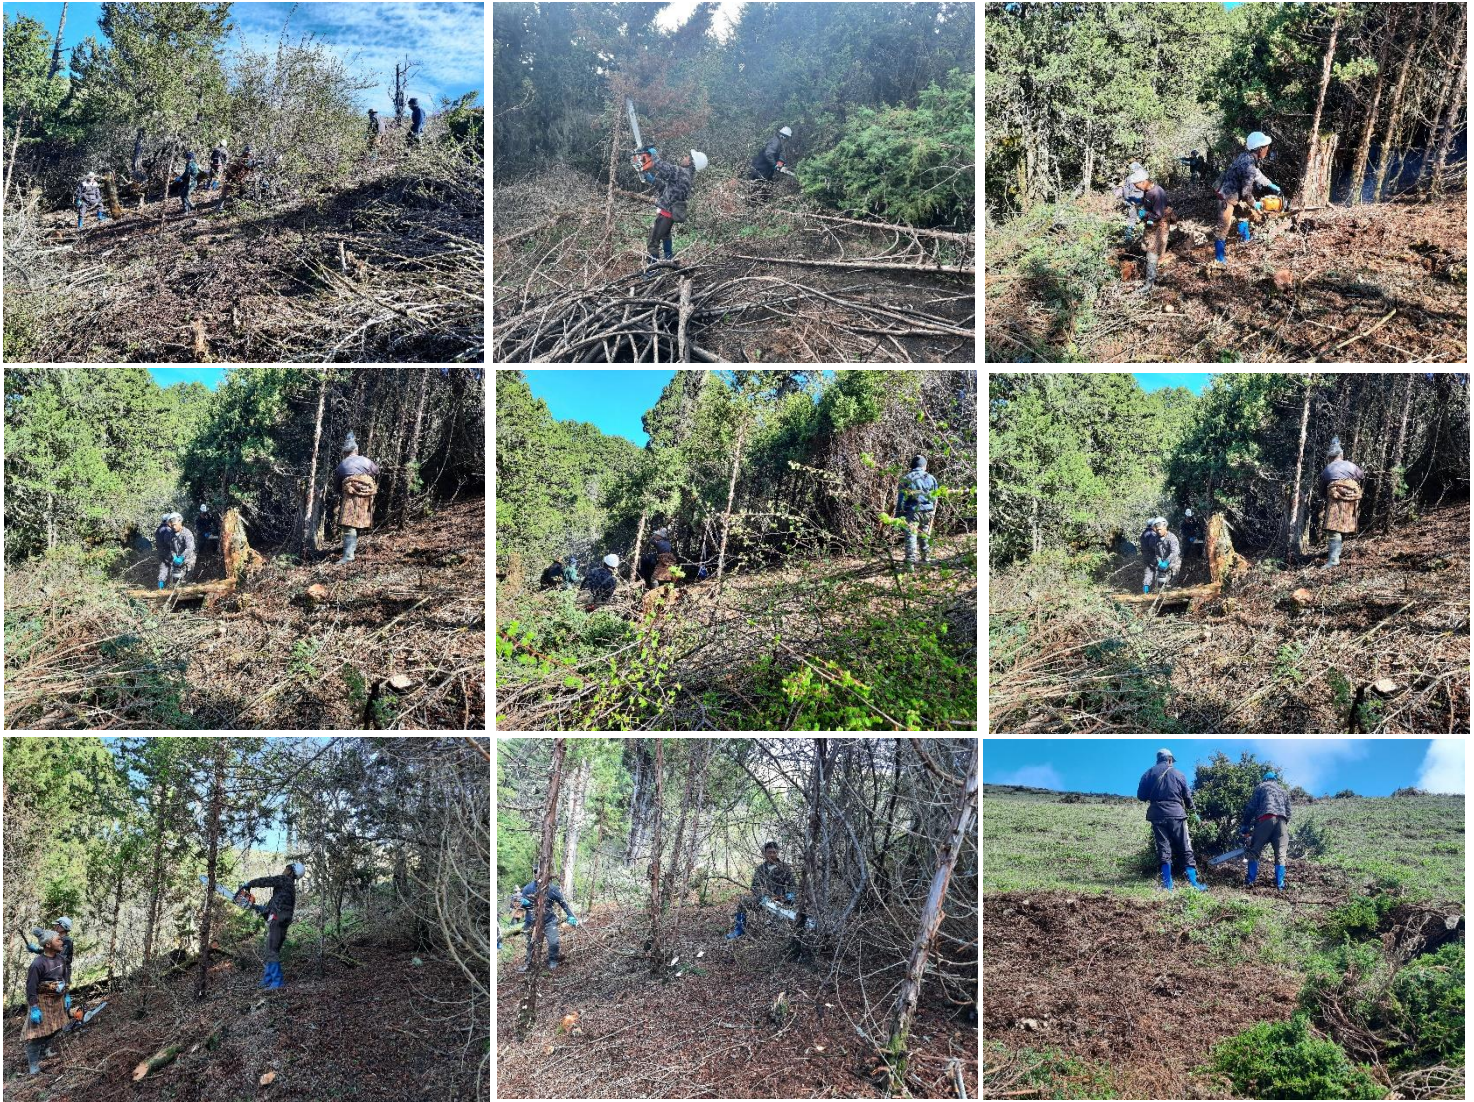
**Photo: Work execution**

Five technical staff, along with two power chain operators and five local laborers, undertook the task of improving the alpine grassland and establishing water holes. The activities include; de-branching overgrown Juniper trees, thinning their saplings and bushy undergrowth, and clearing and cutting off the understory growth of thorny *Rosa sericea* and *Berberis asiatica*, as well as other bushes. These actions aimed to create suitable space for the growth of palatable grasses, thereby maintaining and supporting the sustainability of the profound alpine grassland for a large population of herbivores such as musk deer, sambar deer, blue sheep, gaur, barking deer, serow, and ghoral, while also encouraging and supporting grazing grounds for the

dwindling yak herding communities. Also piled up debris, including debris from de-branching, thinning, and bushes, in appropriate locations for drying and controlled burning later on.

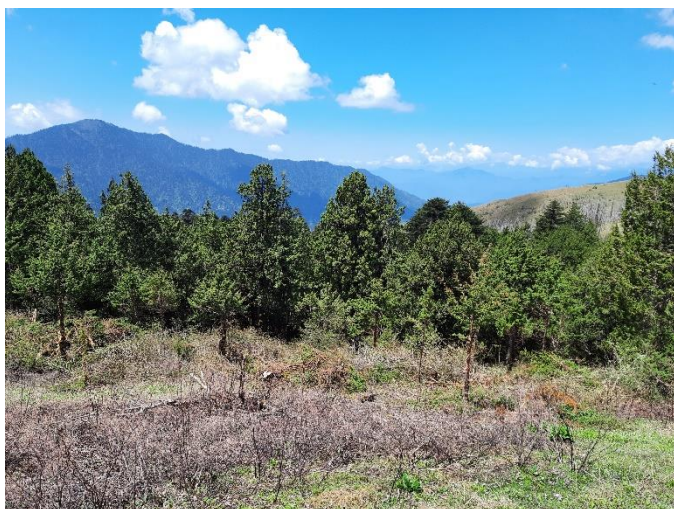
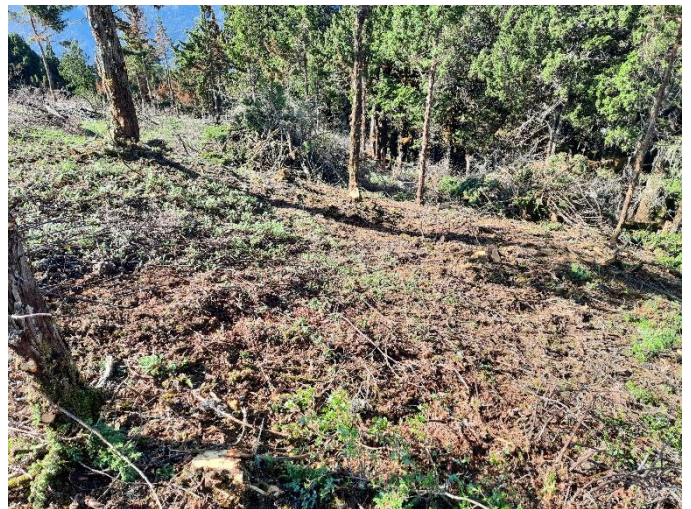
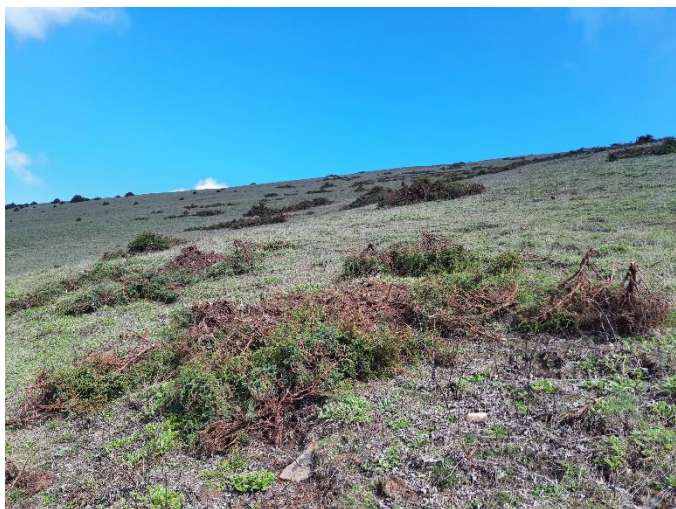
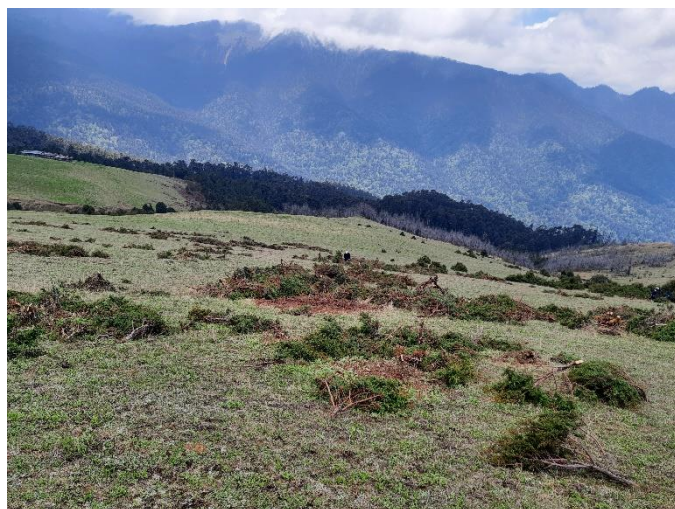
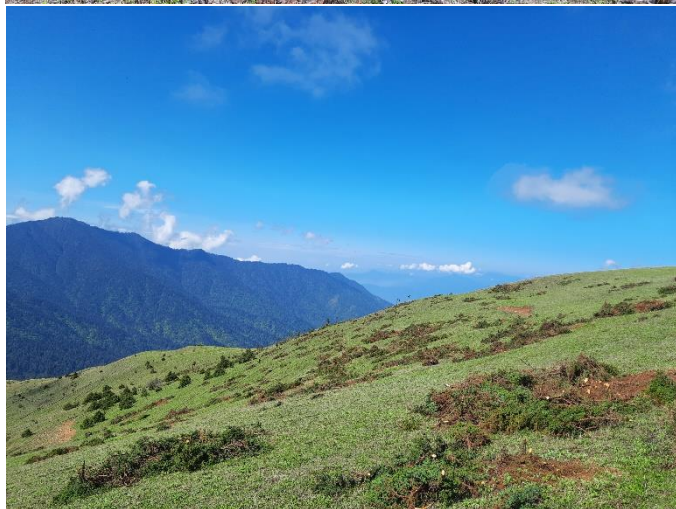
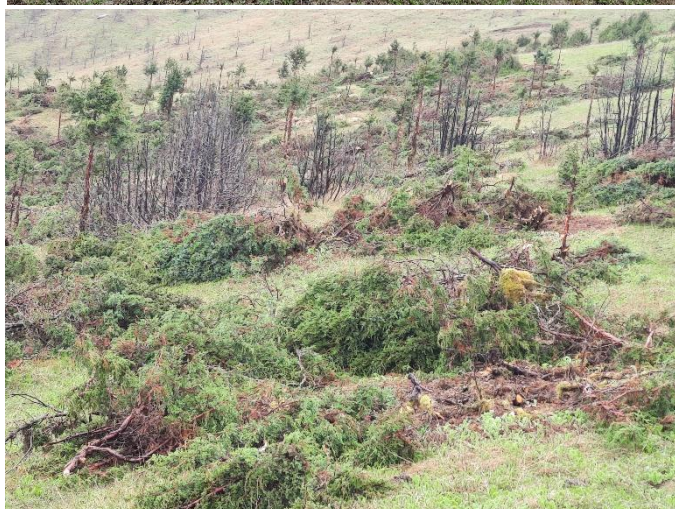
**Photo: After work completion**

Approximately ten hectares of alpine grassland, which were previously used for grazing but later encroached by Juniper and other bushy undergrowth, were opened up to induce the growth of palatable grass species for yaks and wild ungulates.
